United States Department of Agriculture Forest Service Aviation Safety Alert

No. 2002-18

July 22, 2002

Subject: Bell 407 Main Rotor Blade Airworthiness

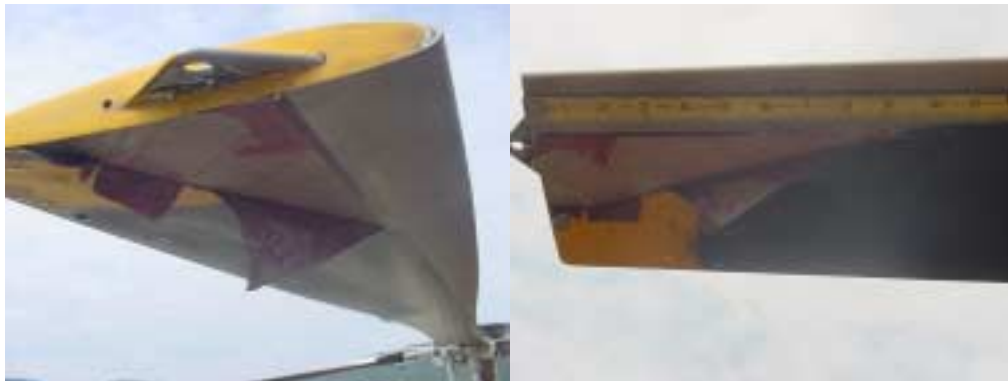
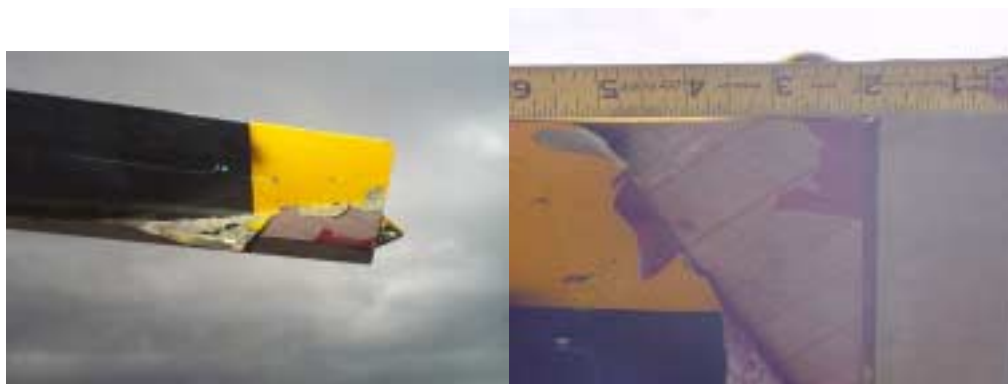
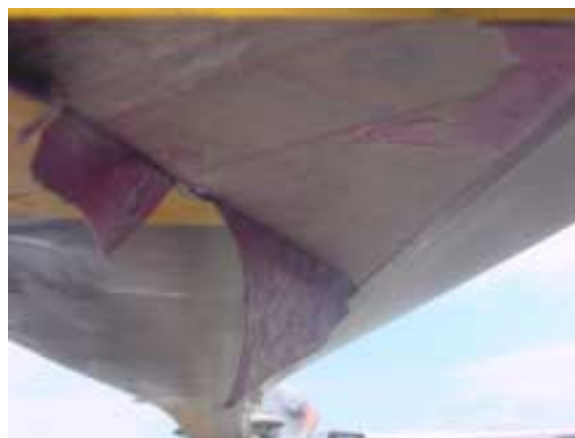
Discussion: On July 16, 2002 a Bell 407 helicopter was on short final to a helibase in Arizona when the pilot experienced a slight yaw to the left, shaking of the cyclic, and a vibration in the helicopter. The pilot chose to take the aircraft to an open flat field approximately ¼ of a mile away to avoid possible injury to personnel on the ground at the helibase. After the helicopter was shut down the aircraft was inspected and it was discovered that the skin on the underside of one of the main rotor blades had de-bonded and separated from the blade tip extending inboard approximately 8 ½ inches. The skin tore away from the blade along a line at the aft lower edge of the leading edge abrasion strip and de-bonded aft approximately four inches. The occurrence is currently under investigation to try to determine the cause of the failure.

The USDA Forest Service is asking all contractors to assure airworthiness of all Bell BHT 407 Main Rotor Blades. This assurance is required prior to further flight after receipt of this safety alert. Regional Aviation Maintenance Inspectors in the Forest Service Regions will be notified as to the status of all contracted (exclusive use or all when needed) Bell BHT 407 helicopters.

If any abnormalities are noted or suspected the aircraft is not to be flown and the operator needs to notify a Forest Service Maintenance Inspector immediately.
